Manhole Inspection Summary

Manhole # S31GG1004MH

Insp Date: **2/12/07 2:25 PM**

Location Address: **105 TUSCANY RD**

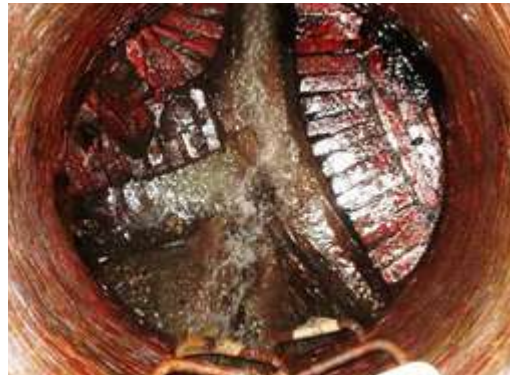
Top View

☒ **Debris** (not Condition related)

☒ **Corroded**

Corroded steps. Bench debris.

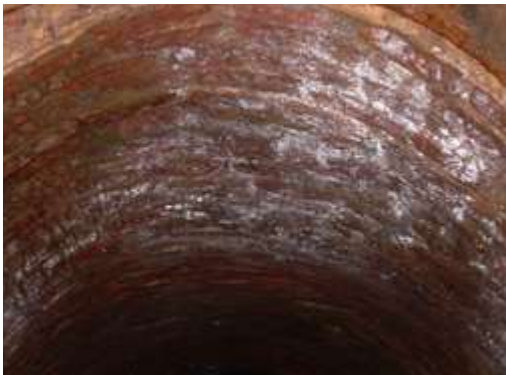
Defect

☒ **Leaks**

Condition: ☐ Sound ☐ Cracked ☐ Root Intrusion ☐ Loose Brick ☒ **Deteriorated**

Infiltration: ☐ None ☒ **Joint** ☐ Cracks ☐ Mortar ☐ Roots ☒ **Wall**

Infiltration: ☐ None ☐ Joint ☐ Cracks ☒ **Mortar** ☐ Roots ☒ **Wall**

Frame leaks. Corbel deterioration and infiltration. Barrel infiltration.

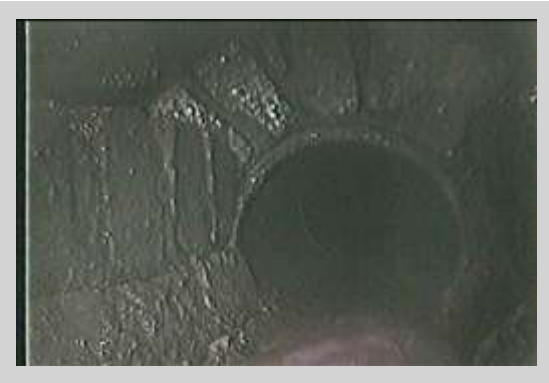
8 in. Circular Gravity Sewer Pipe Out @ 12 O'Clock

Infiltration: **None** Pipe Seal Cond: **Cracked**

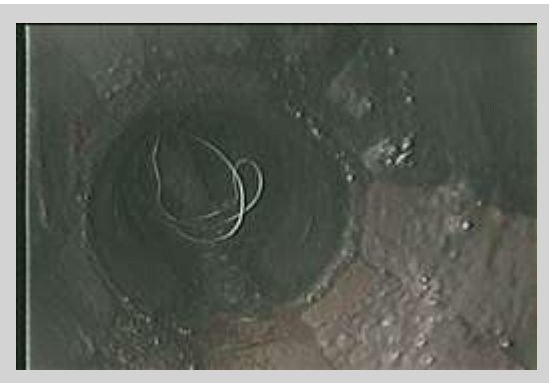
8 in. Circular Gravity Sewer Pipe In @ 5 O'Clock

Infiltration: **None** Pipe Seal Cond: **Unknown**

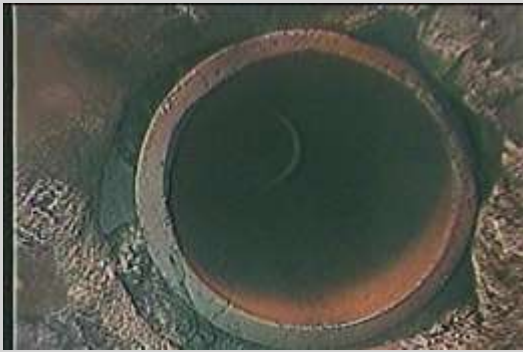
Pipe In @ 6 O'Clock

Infiltration: **Evidence** Pipe Seal Cond: **Broken**

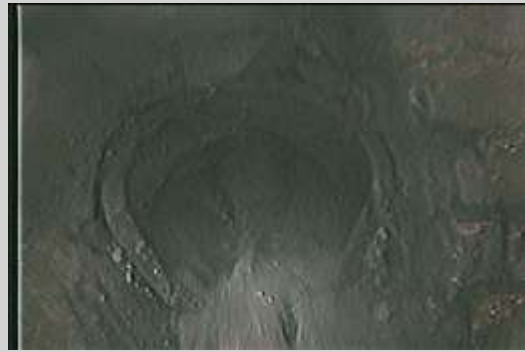
Drop In @ 6 O'Clock

Drop: **Outside** Rod and Bar
Angled: **Yes** Reading: **9.90** (ft.)
Inv Depth: **10.90** (ft.)
Drop Condition: **Open**

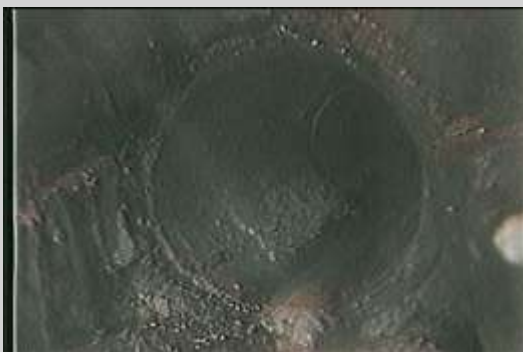
Pipe In @ 9 O'Clock

Deposits: ☐ None ☐ Mud ☐ Sludge ☐ Debris ☒ Grease

Silt Depth: **0** (in.) Deposits Extent: **Light**

Infiltration: **Evidence** Pipe Seal Cond: **Cracked**
